FIRST INTERIM REPORT

DEGRADATION AND REUSE OF RADIATIVE-  
THERMAL-PROTECTION-SYSTEM  
MATERIALS FOR THE SPACE SHUTTLE

NATIONAL AERONAUTICS AND  
SPACE ADMINISTRATION  
GEORGE C. MARSHALL  
SPACE FLIGHT CENTER

E. S. Bartlett, D. J. Maykuth, I. M. Grinberg,  
and R. G. Luce

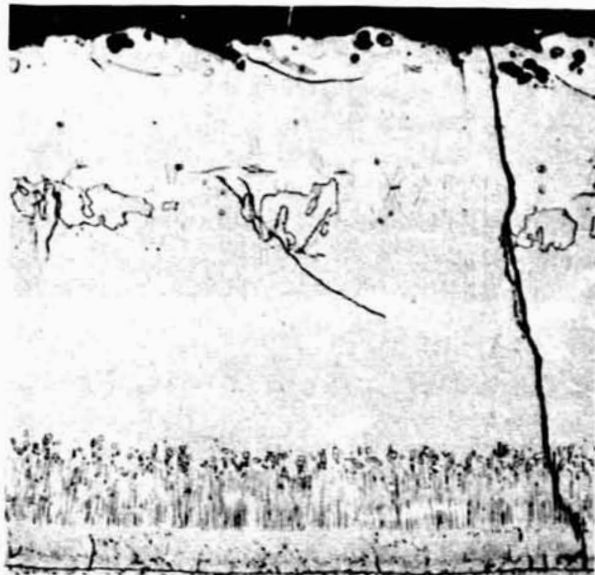
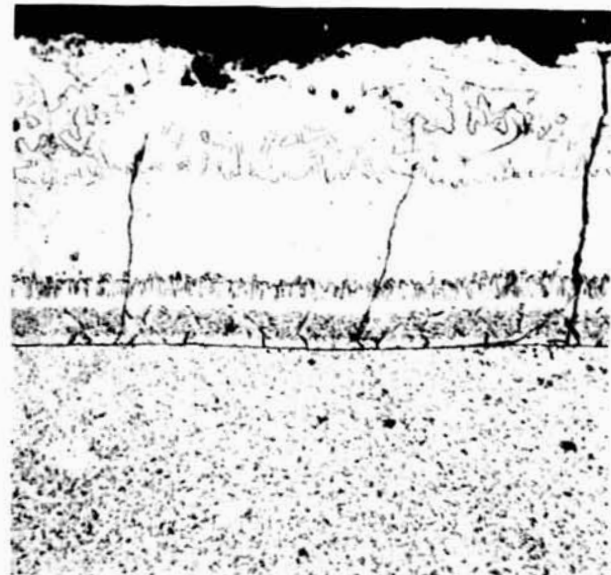
a. Sample R7-3. R512E Coating on Cb752 Substrate

b. Sample R9-1. R512E Coating on C129Y Substrate

c. Sample V7-3. VH109 Coating on Cb752 Substrate

d. Sample V9-3. VH109 Coating on C129Y Substrate

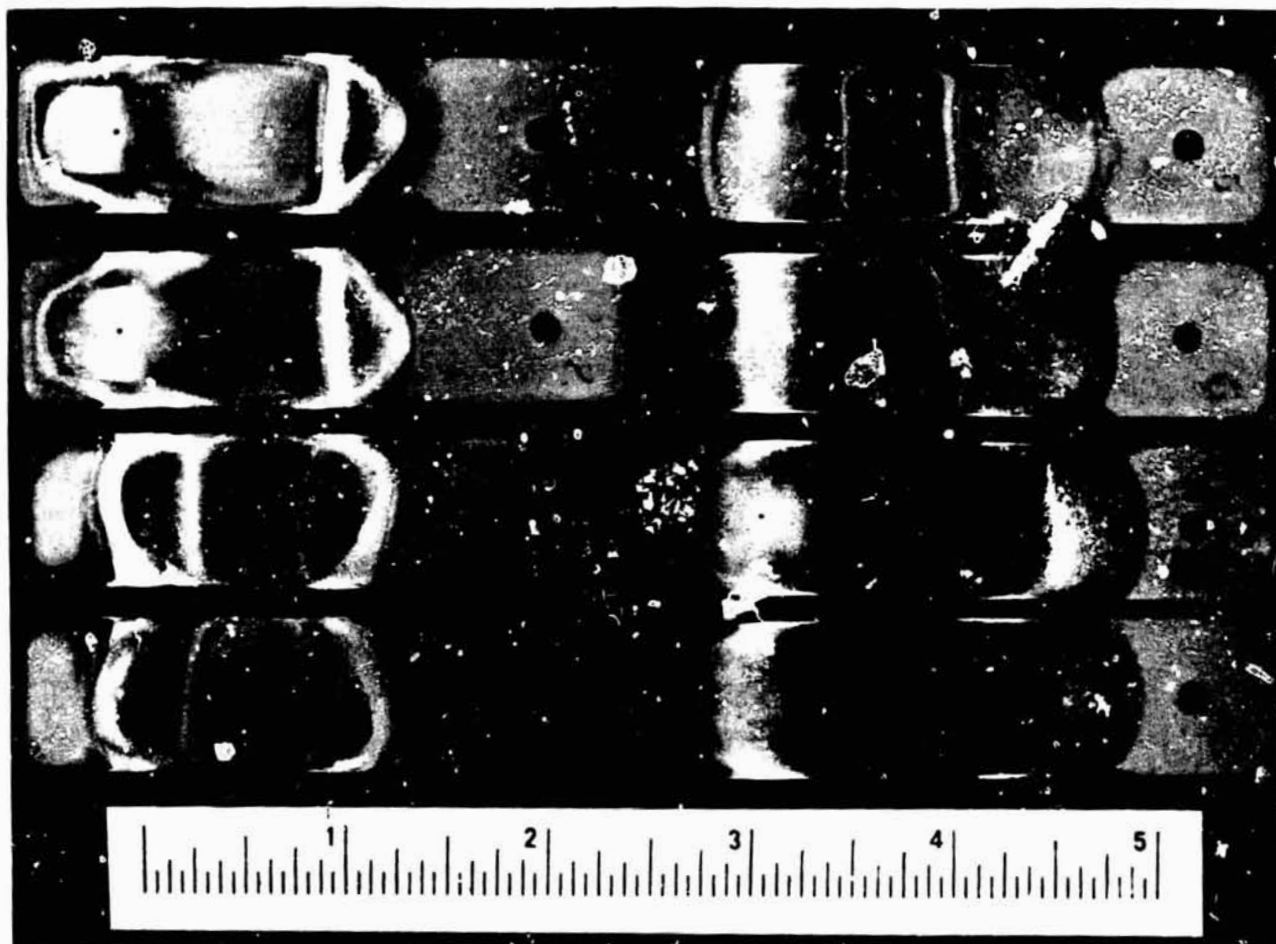
FIGURE 27. APPEARANCE OF INTENTIONALLY DEFECTED COATED COLUMBIUM SPECIMENS AFTER ONE SIMULATED RE-ENTRY CYCLE IN STATIC ENVIRONMENT

Static Environment. Figure 27 shows the appearance of the eight intentionally defected coated columbium specimens (Specimens S1 through S8) after one simulated reentry cycle in the static environment which included a 15-minute exposure at 2500 F. In all cases, the specimens were suspended vertically from the large holes provided at

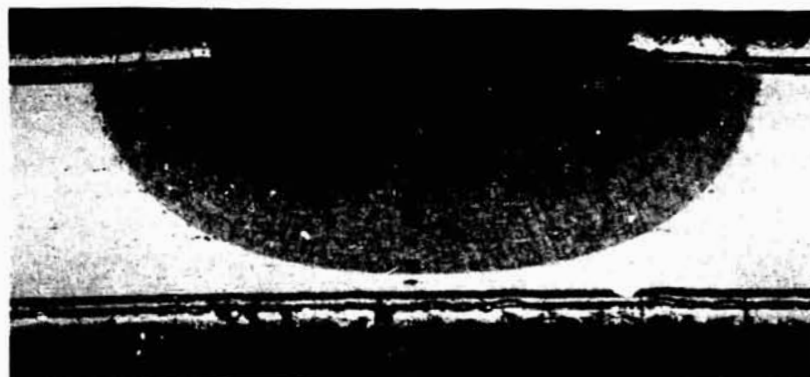
a. Defect 8B-3 on R512E/Cb752; Initially  
41 Mils in Diameter by 4 Mils Deep

b. Defect 8E-3 on VH109/C129Y; Initially  
41 Mils in Diameter by 5.5 Mils Deep

FIGURE 33. LONGITUDINAL SECTIONS THROUGH COATING-DEFECT  
SITES ON SPECIMENS AFTER ONE DYNAMIC REF NTRY  
PROFILING CYCLE

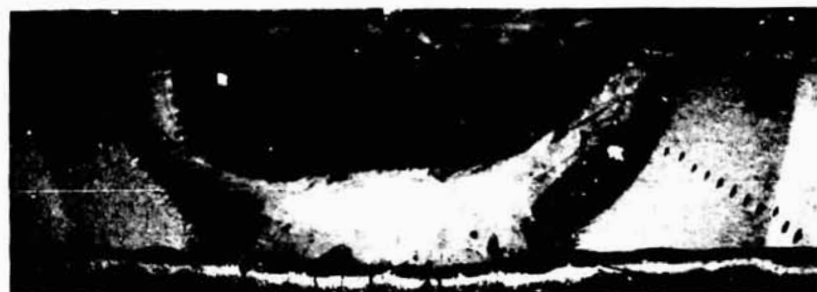
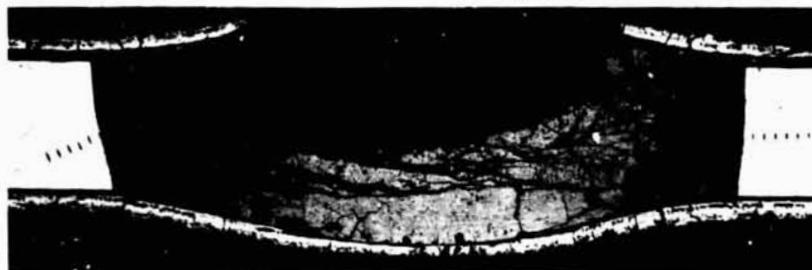
a. Defect 8D-1 on VH109/Cb752; Initially  
4.7 Mils in Diameter by 5.5 Mils Deep

b. Defect 8E-1 on VH109/C129Y; Initially  
4.7 Mils in Diameter by 5.5 Mils Deep
